**Re: Cleanup and Abatement Order R9-2002-0016
Sycamore Vista Business Center**

**Buie Communities' Sycamore Vista Business Park
Regional Water Quality Control Board
Cleanup and Abatement Order
Resolution Program**

**Preliminary Concept Plan for the
Implementation of Restoration, Mitigation, and Passive Stormwater Discharge Best
Management Practices Along the Agua Hedionda Creek Corridor within the Sycamore
Vista Business Park**

FACILITY INSPECTION REPORT

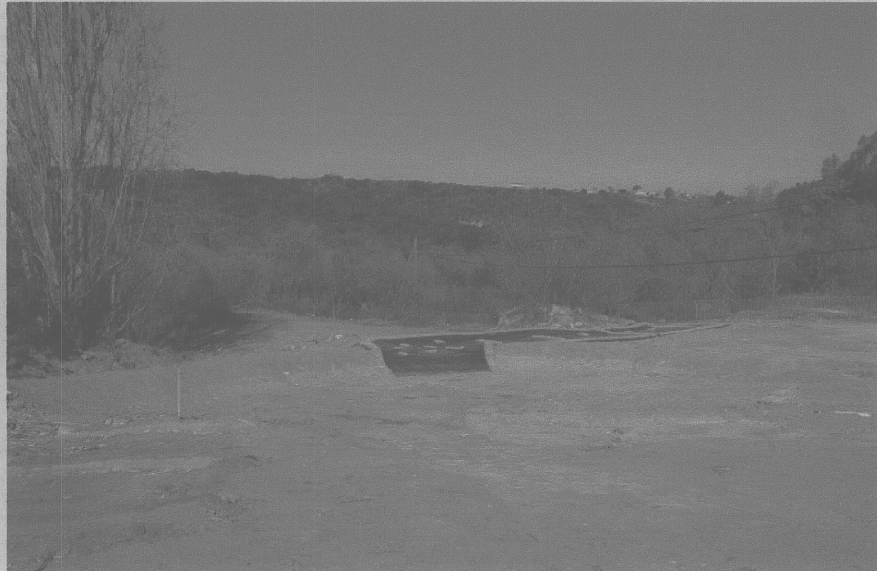
Discharge point off-site to tributary of Agua Hedionda Creek. A sedimentation basin will be implemented here to reduce discharge of sediment into tributary.

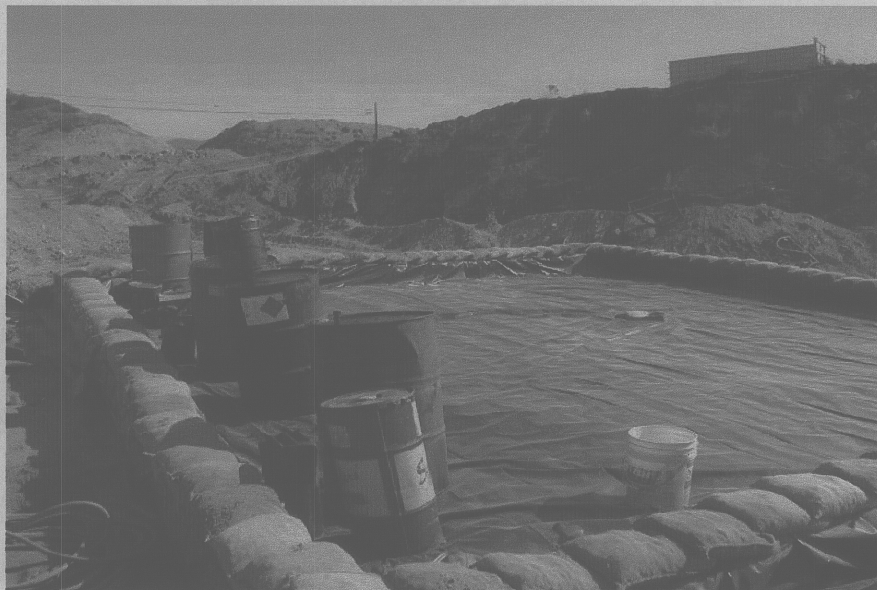
- Hazardous materials storage: Buie has constructed a lined bermed storage area for petroleum products. WYROC's fueling area is a mess, contaminated soil, not adequately contained. Buie stated it will be taken care of immediately.

Buie has improved their BMPs for storage of hazardous materials. There is still work that needs to be done.

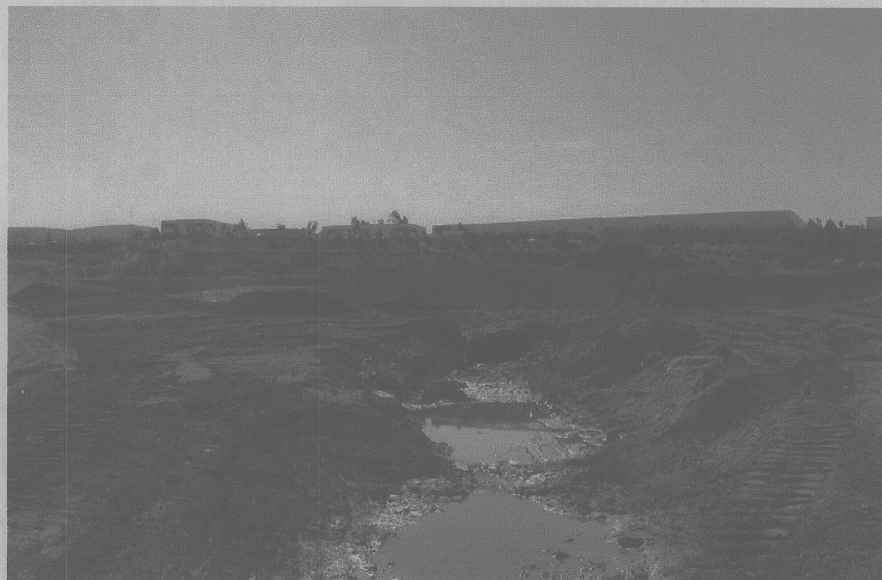
Urban runoff from developments offsite is flowing across site. Buie needs to ensure it doesn't pick up additional sediment as it crosses site.

- Run on from nuisance flow coming onto site, crossing east → west discharging into old sedimentation basin constructed by WYROC, which has become habitat. Buie will create a series of check dams to slow flow & allow sediment to drop out, before discharging to side drainage of Agua Hedionda.

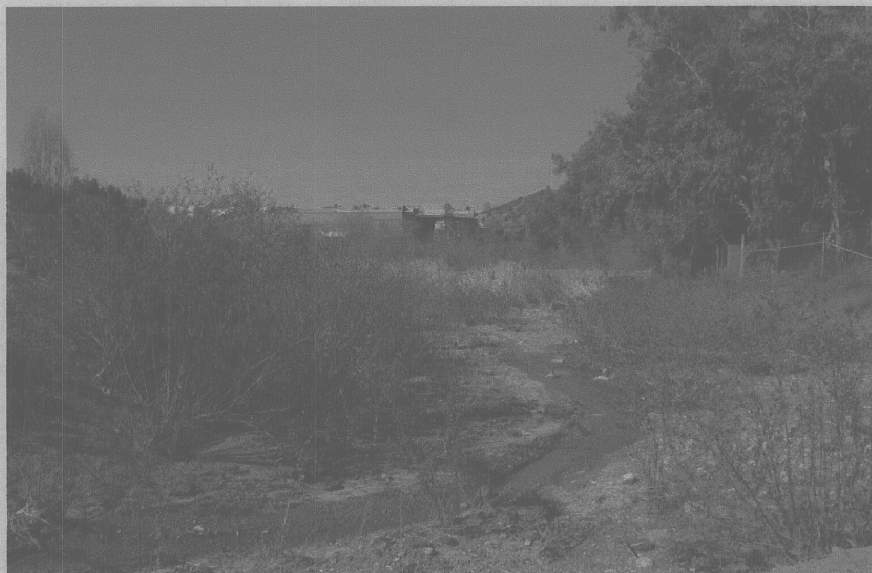
Run-on flowing across site flows into historic sedimentation basin constructed by quarry operators, which has become habitat.

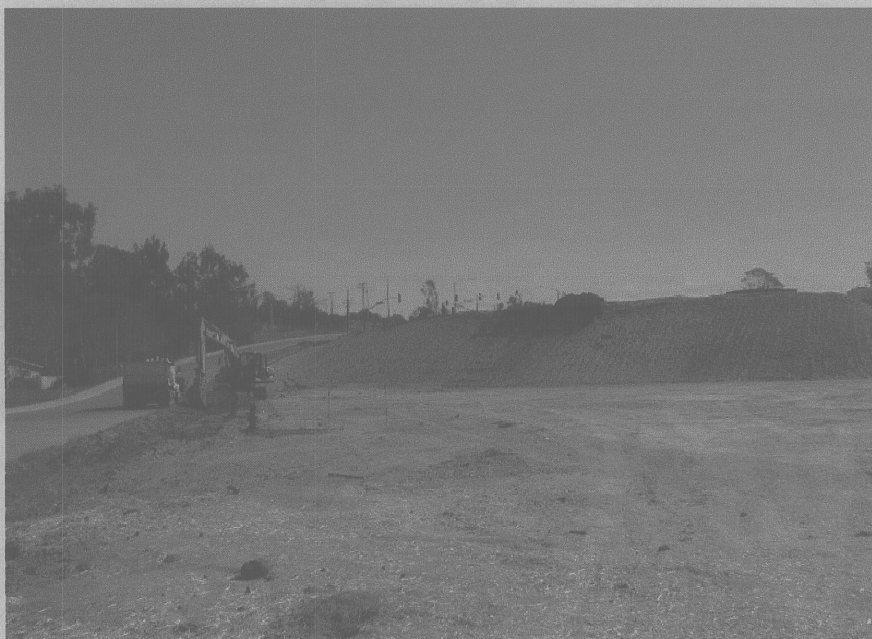
Lower portion of site, adjacent to Agua Hedionda Creek has been cleaned up, and covered with mulch & tackifier temporary erosion control/
